Composite Universal Weapons Pylon Damage Tolerance Test Report

Jay P. Kiser II

Aviation Applied Technology Directorate US Army RDECOM, AMRDEC RDMR-AAF Fort Eustis, VA 23604-5577

29 October 2010

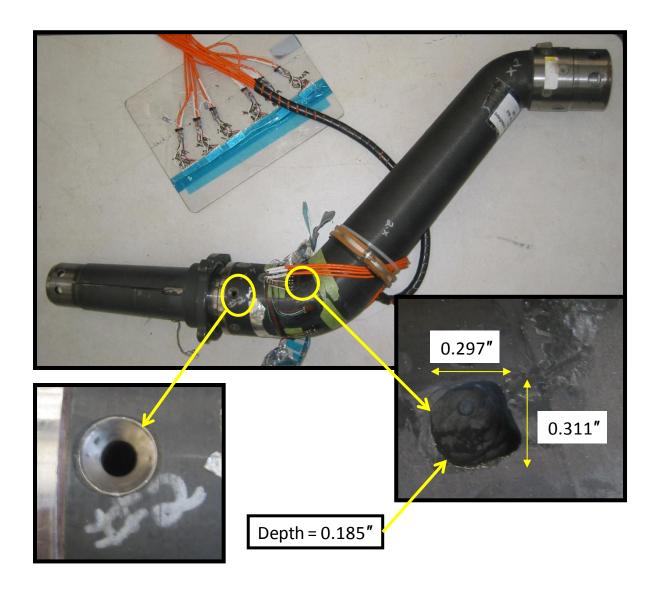
The CUWP test article that was used in the fatigue test (Reference a) was also used for this sequence of damage tolerance testing. The test article was modified by introducing damage into the composite tube and also removing the #2 fastener (Figure 1). The damage introduced into the test article consisted of a bore drilled approximately halfway into the composite tube using a tungsten carbide drill bit. The drilling of a round hole through the entire 0.40" thick tube was not performed since the unsymmetrical bore provided a higher stress concentration factor. The location of the bore was chosen at the maximum principle strain due to the .50 caliber gun cyclic loading based upon the OEM analysis. The effect of the bore simulates a delamination in the composite structure. The #2 fastener was removed since this fastener exhibited the highest bearing load into the titanium fitting based upon the OEM analysis. The removal of the #2 fastener causes the load to be transferred to adjacent fasteners.

Figure 1. CUWP Test Article with Bore and #2 Fastener Removed

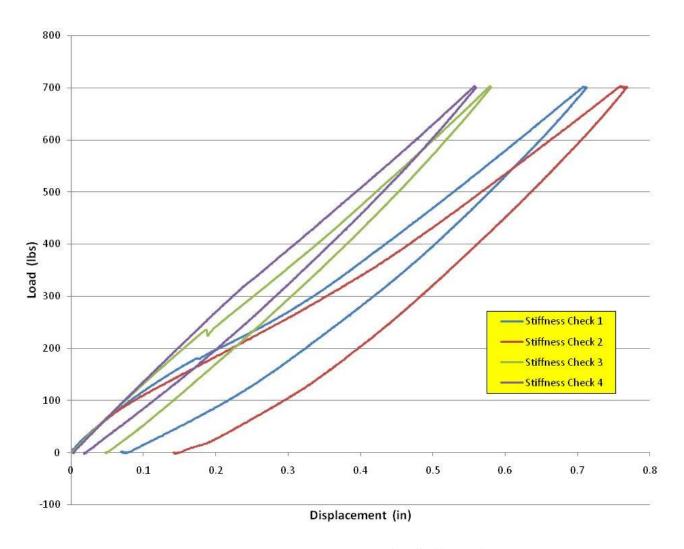
Prior to each load case, the CUWP test article was subjected to a stiffness check in order to determine if any variations in stiffness occurred during the cyclic loading. The stiffness checks consisted of one stroke up to a load limit of 700-lbs. Load as a function of displacement was recorded for each of the first four stiffness checks (Figure 2). The stiffness of the test setup generally increased as more stiffness checks were performed. This was likely due to the interface of the collet assembly and the lower test fixture. Tightening the collet nut expanded the collet providing a frictional interface between the collet and the test fixture. When the test article was subjected to cyclic loading, the collet had the tendency to seat into the fixture. As more cyclic loading was performed, more seating took place. Since the collet nut was re-torqued to the required 250-260 ft·lbs prior to each stiffness check, it is logical to conclude that the changing stiffness of the test setup was the result of the increased seating of the collet.

Figure 2. Load vs. Displacement for Stiffness Checks 1-4

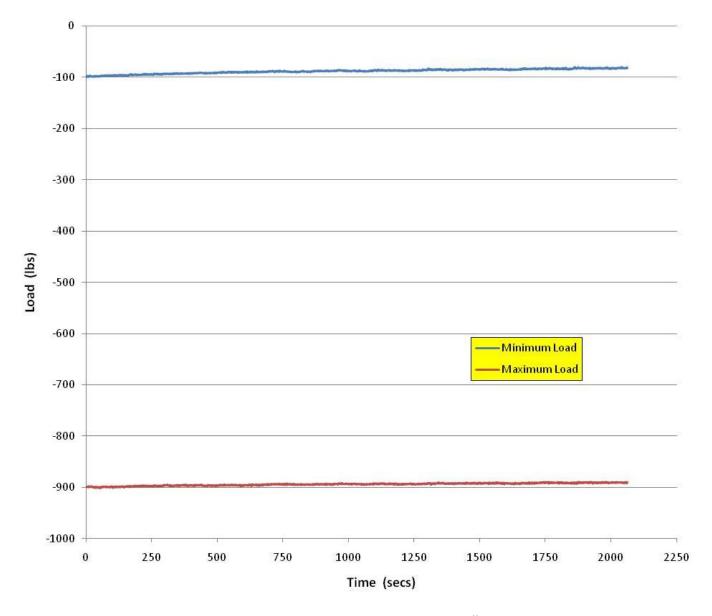
Figure 3. Cyclic Load vs. Time, Case #1a

Cyclic Load Case #1a simulated the firing of HELLFIRE missiles for 4,200 cycles. Load as a function of time for Cyclic Load Case #1a was recorded (Figure 3). The cyclic loading was performed at two hertz. The hydraulic actuator and load cell was subjected to displacement control thus the maximum and minimum displacement values were -0.96" and -0.18", respectively. The load curves are smooth indicating that no anomalies were recorded.

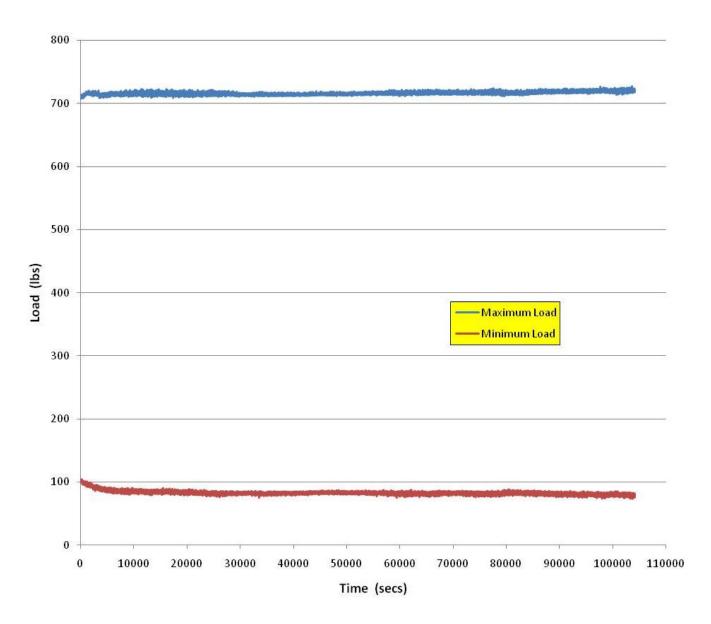
Figure 4. Cyclic Load vs. Time, Case #2a

Cyclic Load Case #2a simulated the firing of a .50 caliber machine gun for 420,000 cycles. Load as a function of time for Cyclic Load Case #2a was recorded (Figure 4). The cyclic loading was performed at four hertz. The hydraulic actuator and load cell was subjected to displacement control thus the maximum and minimum displacement values were 0.70" and 0.23", respectively. The load curves are smooth indicating that no anomalies were recorded.

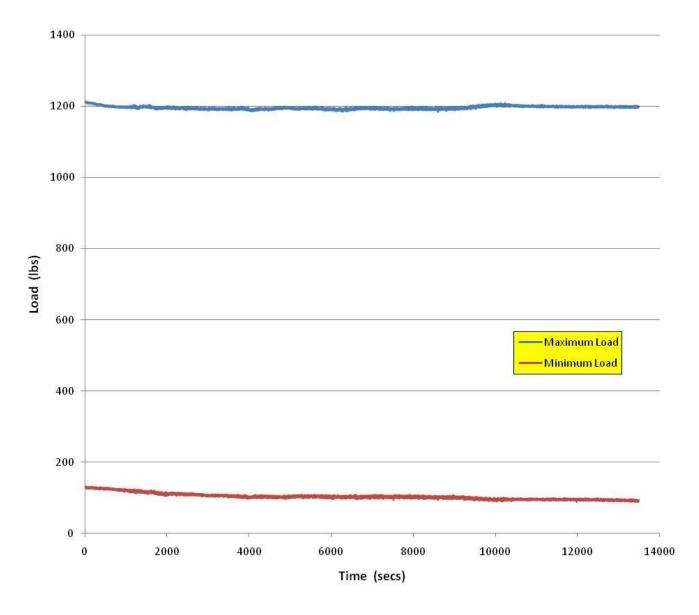
Figure 5. Cyclic Load vs. Time, Case #3a

Cyclic Load Case #3a simulated the firing of Hydra rockets for 42,000 cycles. Load as a function of time for Cyclic Load Case #3a was recorded (Figure 5). The cyclic loading was performed at three hertz. The hydraulic actuator and load cell was subjected to displacement control thus the maximum and minimum displacement values were 0.97" and 0.17", respectively. The load curves are smooth indicating that no anomalies were recorded. This completed the first block of cyclic testing.

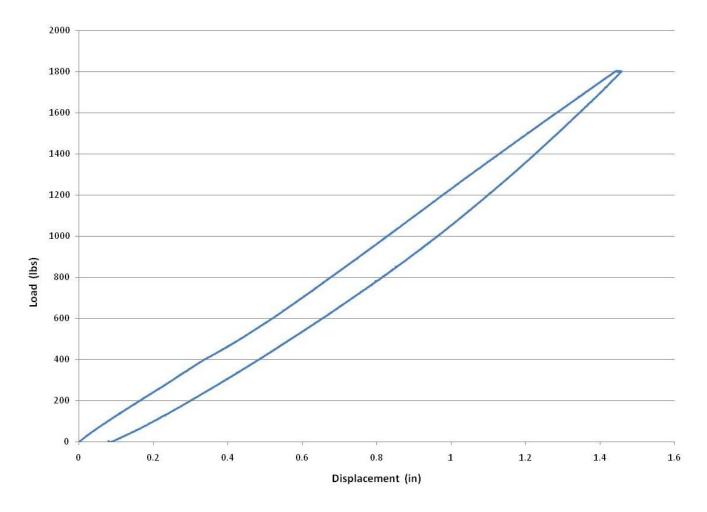
Figure 6. Load vs. Displacement, Proof Load Case #1a

Proof Load Case #1a simulates Hydra rocket loading and was conducted to demonstrate no stiffness or strength reduction occurred in the test article after the completion of the of the first block of cyclic loading. Load as a function of displacement was recorded for Proof Load Case #1a (Figure 6). The load was applied with a 120 second ramp up duration, held constant for 30 seconds, and then released with a 120 second ramp down duration. The test article underwent elastic hysteresis but did not return to exactly zero displacement. In addition, there was a slight increase in displacement during the 30 second duration when the load was held constant. This may have been the result of the test article experiencing slip, a slippage of the support structure, and/or the collet seating. Regardless, the displacement variations can be considered negligible for the purposes of this test since the 1800-lbs proof load was conducted to show that the test article could hold 1.5 times the Hydra rocket load after cyclic loading without structural failure.

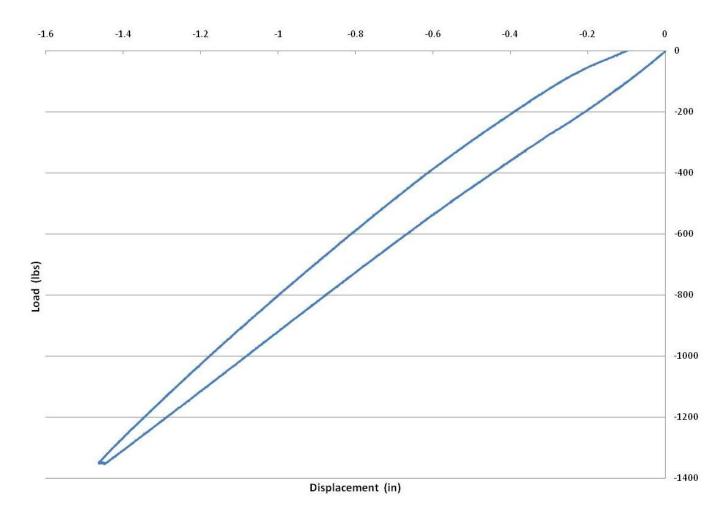
Figure 7. Load vs. Displacement, Proof Load Case #2a

Proof Load Case #2a simulates HELLFIRE missile loading and was conducted to demonstrate no stiffness or strength reduction occurred in the test article after the completion of the of the first block of cyclic loading. Load as a function of displacement was recorded for Proof Load Case #2a (Figure 7). The load was applied with a 120 second ramp up duration, held constant for 30 seconds, and then released with a 120 second ramp down duration. The test article underwent elastic hysteresis but did not return to exactly zero displacement. In addition, there was a slight increase in displacement during the 30 second duration when the load was held constant. This may have been the result of the test article experiencing slip, a slippage of the support structure, and/or the collet seating. Regardless, the displacement variations can be considered negligible for the purposes of this test since the -1350 lbs proof load was conducted to show that the test article could hold 1.5 times the HELLFIRE missile load after cyclic loading without structural failure.

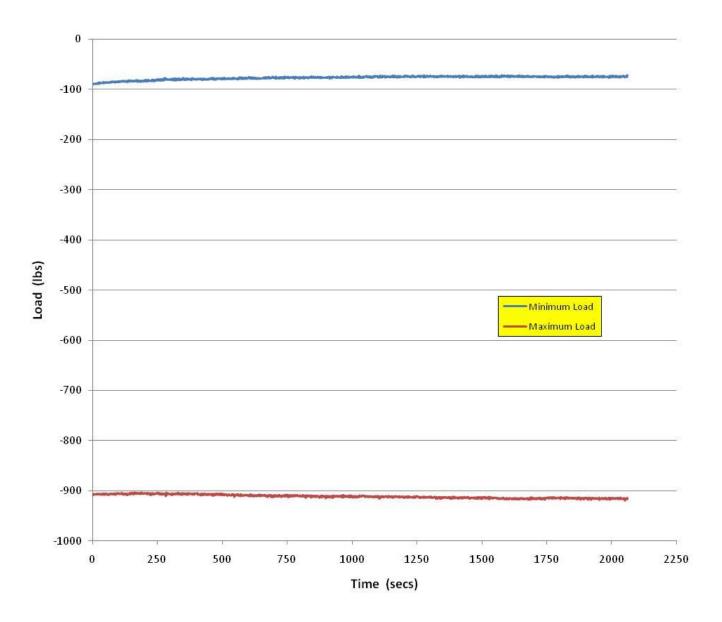
Figure 9. Cyclic Load vs. Time, Case #1b

The second cyclic HELLFIRE missiles loading spectrum was applied for 4,200 cycles. Load as a function of time for Cyclic Load Case #1b was recorded (Figure 9). The cyclic loading was performed at two hertz. The hydraulic actuator and load cell was subjected to displacement control thus the maximum and minimum displacement values were -1.07" and -0.29", respectively. The load curves are smooth indicating that no anomalies were recorded.

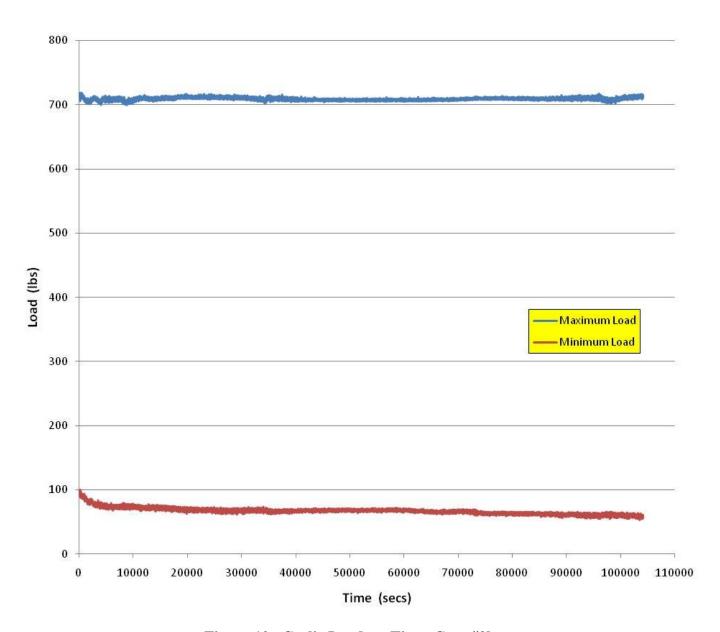
Figure 10. Cyclic Load vs. Time, Case #2b

The second cyclic .50 caliber machine gun loading spectrum was applied for 420,000 cycles. Load as a function of time for Cyclic Load Case #2b was recorded (Figure 10). The cyclic loading was performed at four hertz. The hydraulic actuator and load cell was subjected to displacement control thus the maximum and minimum displacement values were 0.66" and 0.19", respectively. The load curves are smooth indicating that no anomalies were recorded.

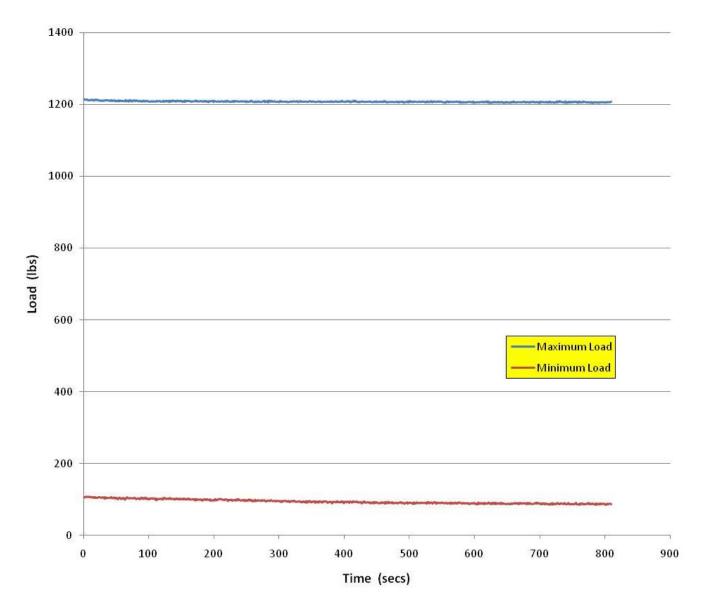
Figure 11. Cyclic Load vs. Time, Case #3b

The second cyclic Hydra rocket loading spectrum was applied for 42,000 cycles. Load as a function of time for Cyclic Load Case #3b was recorded (Figure 11). Only the first 810 seconds of data was recorded due to a data acquisition failure. The cyclic loading continued to run for the full 42,000 cycles without any anomalies reported. The cyclic loading was performed at three hertz. The hydraulic actuator and load cell was subjected to displacement control thus the maximum and minimum displacement values for this limited data set were 0.99" and 0.18", respectively.

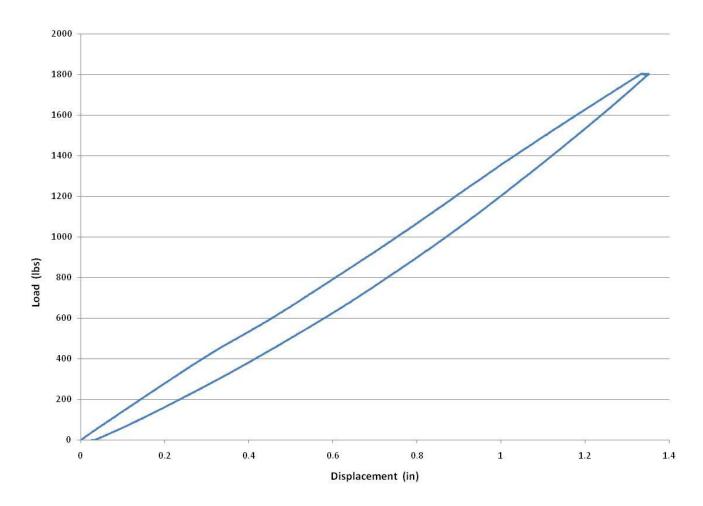
Figure 12. Load vs. Displacement, Proof Load Case #1b

Proof Load Case #1b simulates Hydra rocket loading and was conducted to demonstrate no stiffness or strength reduction occurred in the test article after the completion of the of the second block of cyclic loading. Proof Load Case #1b was conducted in the same manner as Proof Load Case #1a. Load as a function of displacement was recorded for Proof Load Case #1b (Figure 12). A slight decrease in maximum displacement occurred during Proof Load Case #1b compared to Proof Load Case #1a. The difference in displacement is less than 10% and can be considered negligible. Therefore, it is logical to conclude that no stiffness or strength reduction occurred as a result of the second block of cyclic loading.

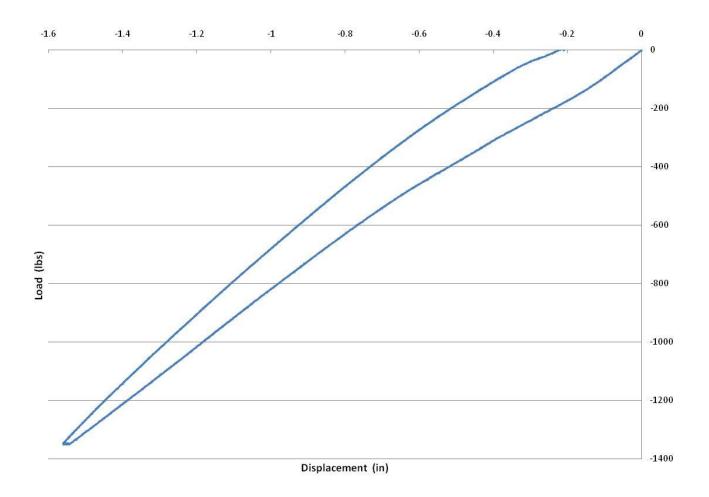
Figure 13. Load vs. Displacement, Proof Load Case #2b

Proof Load Case #2b simulates HELLFIRE loading and was conducted to demonstrate no stiffness or strength reduction occurred in the test article after the completion of the of the second block of cyclic loading. Proof Load Case #2b was conducted in the same manner as Proof Load Case #2a. Load as a function of displacement was recorded for Proof Load Case #2b (Figure 13). A slight increase in maximum displacement occurred during Proof Load Case #2b compared to Proof Load Case #2a. The difference in displacement is less than 10% and can be considered negligible. Therefore, it is logical to conclude that no stiffness or strength reduction occurred as a result of the second block of cyclic loading.
